IN THE SUMMARY COURT AT GEORGE TOWN

PLAINT

## Analysis for Collision Involving Honda Airwave 164 472 and BMW 525i 121 552

**Reason for Inspection:** Post Crash Analysis

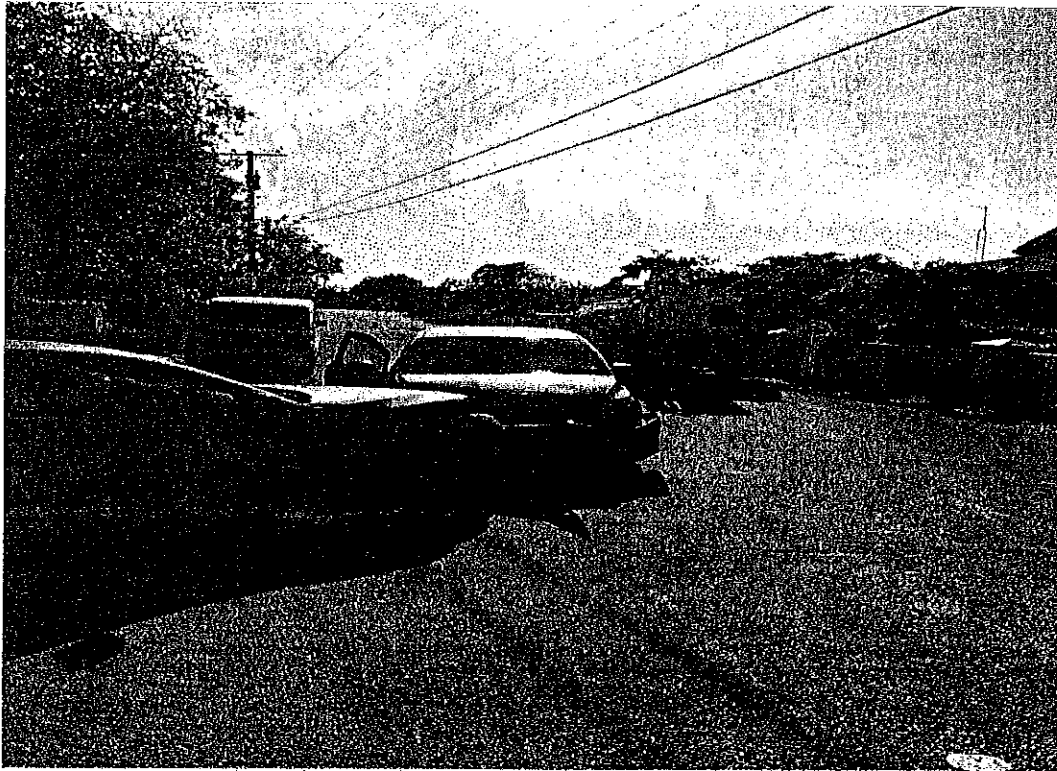
Pic showing the scene at the stop sign controlled junction with both vehicles at final rest. The BMW is pulling out from the stop sign controlled junction and the Honda is passing a stationary work van.

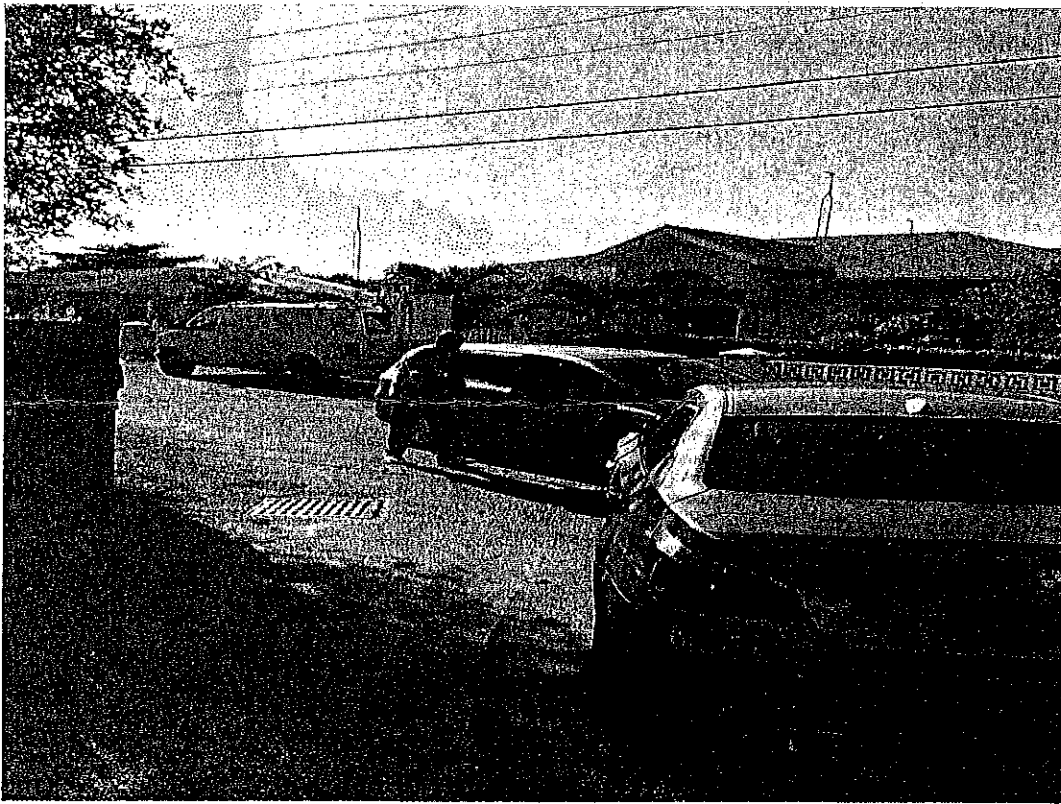
Pic showing the view from the stop sign controlled junction where the BMW is pulling out from when it collided into the passing Honda who is on the main road. The fence to the left of the BMW at the junction causes an obstruction in the line-of sight from the driver of the BMW who should proceed slowly as they attempt to pull out from the stop sign junction to ensure that the way is clear.

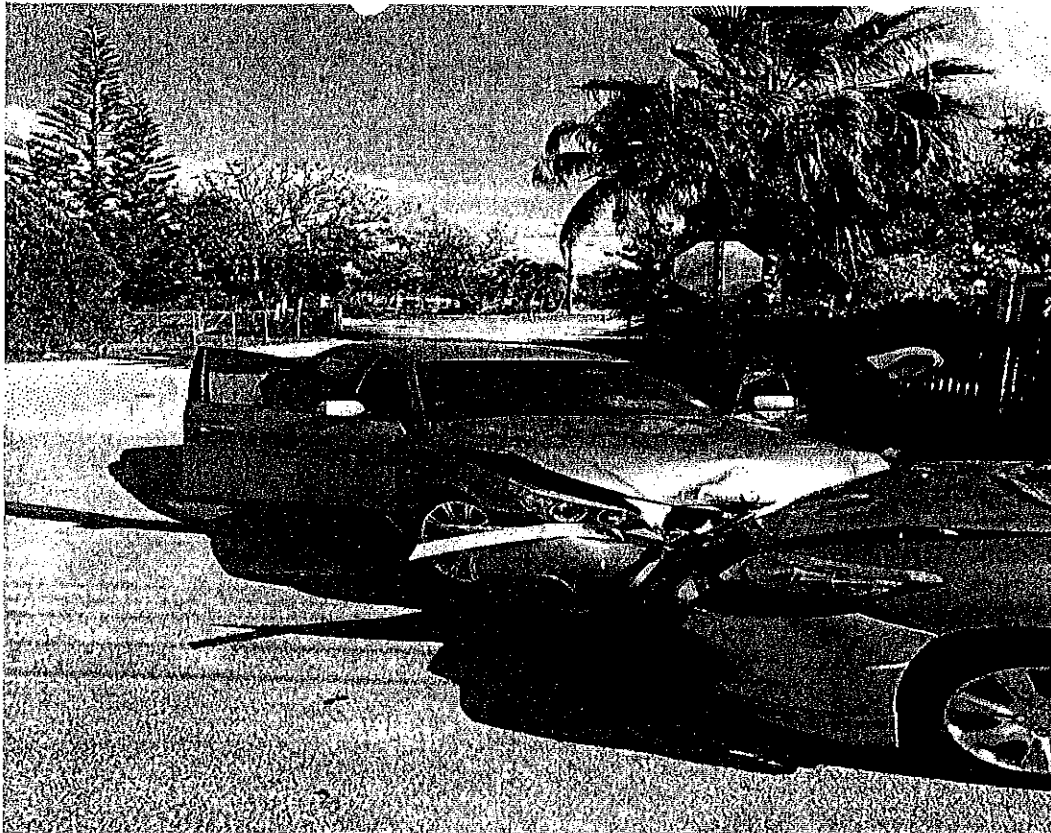
Pic showing the view looking from the Parkview Crescent onto the stop sign controlled junction on Mount Pleasant Road where the BMW is pulling out from and turning left when the collision occurred. The driver of the BMW stated in his written statement on his claim form that he was moving off from the stop sign where he looked to the right side of the intersection as he moved off to go around the corner.

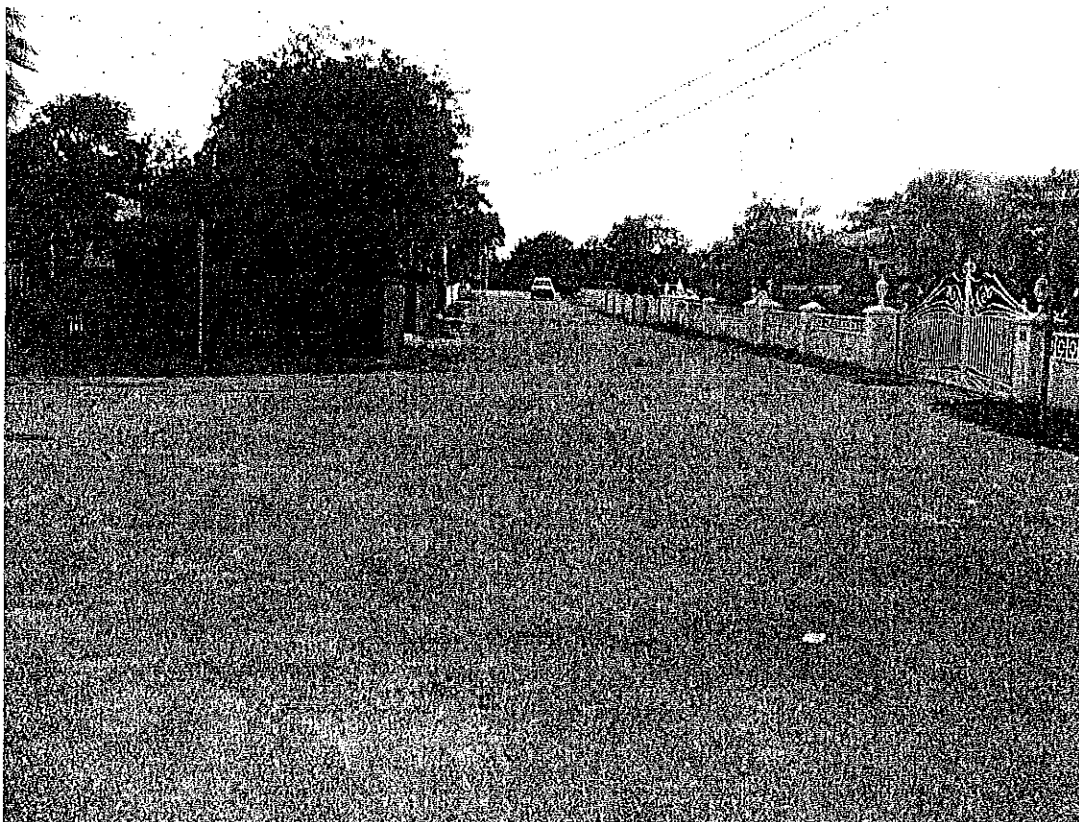
Pic showing the scene visit at the junction. The stop sign is located at the junction where Mount Pleasant Rd meets Parkview Crescent indicating that the traffic should stop and ensure it clear before turning onto Parkview Crescent.
